**RECOMMENDATIONS FOR THE RE-ESTABLISHMENT
OF SALMONIDS IN SPANISH BANKS CREEK**

**Department of Fisheries and Oceans Canada
Salmonid Enhancement Program
New Westminster, B.C.**

March 1994.

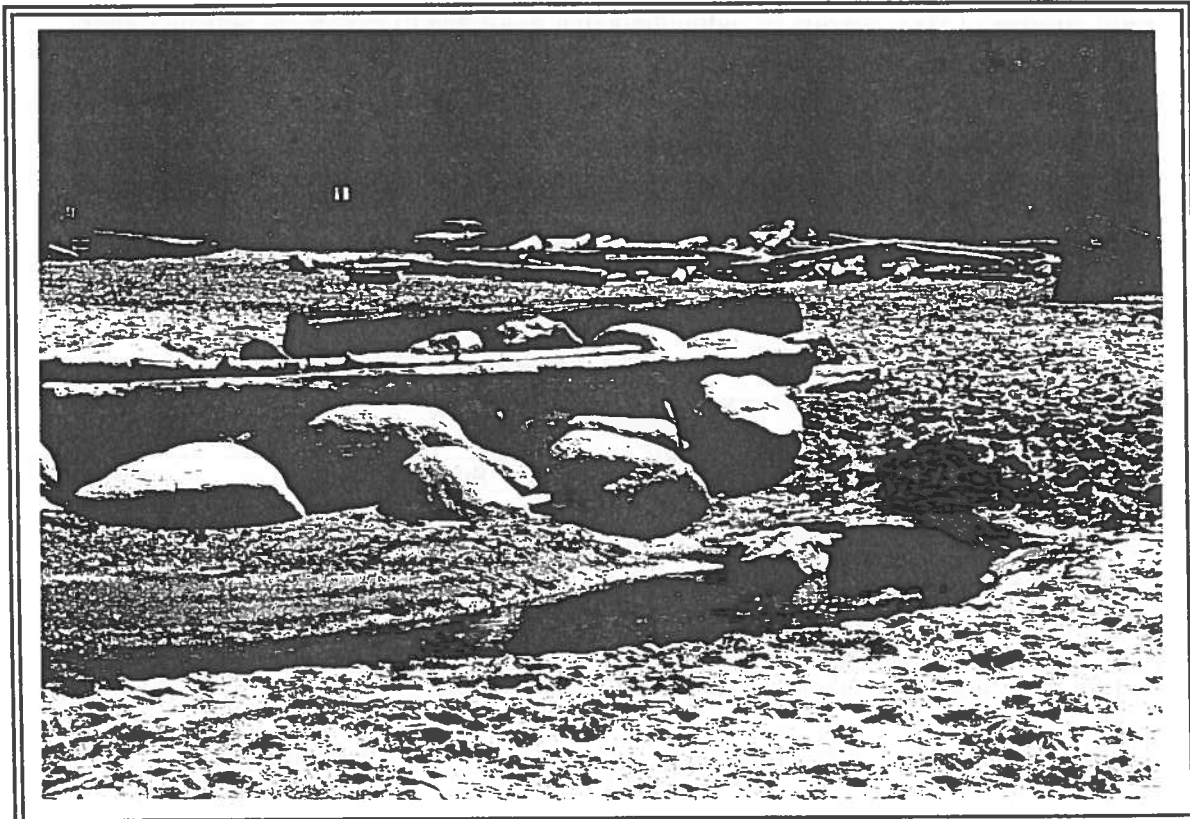
Salmon are prevented from naturally recolonizing Spanish Banks Creek because of an 85 m culvert running from above Marine Drive to part way down Spanish Banks beach. The elevation of the culvert outlet is approximately 4.35 m above Canadian chart datum¹ (Figure 2). Above this culvert the stream is capable of supporting salmonids, as demonstrated by the success of the released juvenile coho in 1991, 1992, and 1993 (M. Johnson pers. comm.). Rearing habitat is typical of small streams in areas that have been previously logged. There are relatively few pools and consequently, a reduced ability to retain water during low flows. Suitable gravel substrate sites for spawning are present.

Fig. 2: Existing outlet of Spanish Banks Creek.

Removing the lowest 38 m of the culvert under Spanish Banks beach and allowing the stream channel to reach an equilibrium as it flows across the sand will provide access at high tides over 4.7 m to both coho salmon and cutthroat trout. At tide heights below 4.7 m upstream access by salmonids would be precluded in moderate flow conditions because of shallow water levels in the stream channel. As well, chum salmon which are suited to streams like Spanish Banks Creek, are notorious for only spawning below long culverts such as the 45 meter section that will remain under the parking lot and Marine Drive. To provide habitat for chum salmon a tidal estuary at the outlet of the creek should be created to provide spawning sites (chum salmon eggs are tolerant of saltwater conditions). The estuary can be designed to provide access to the culvert at a range of tide heights.
