**The effects of canopy closure on precipitation
throughfall: Ecological restoration considerations
for Spanish Bank Creek**

Project Submitted in Partial Fulfillment of the
Requirements for the Degree of
Master of Science

in the
Ecological Restoration Program

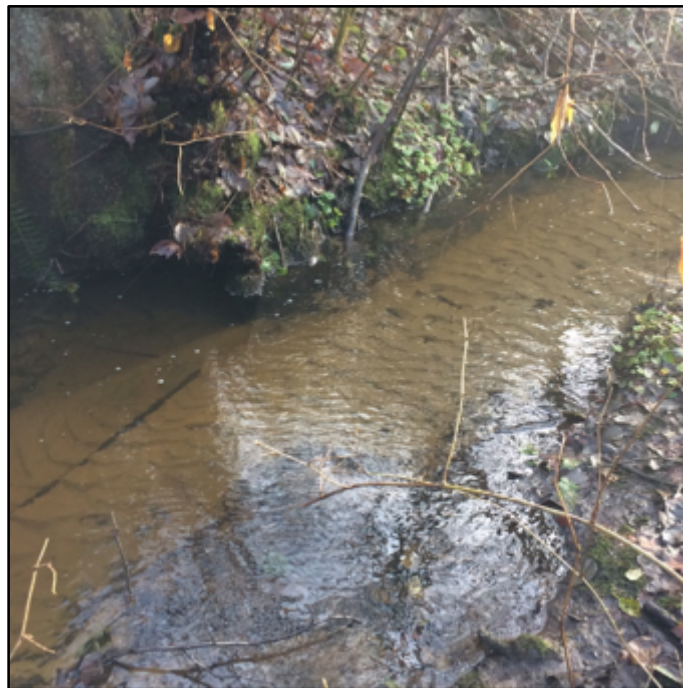
Figure 2: A thick layer of inorganic sediment has accumulated behind a downed tree that has fallen across Spanish Bank Creek. Longitudinally, this sediment has accumulated for approximately 15 m upstream of the downed tree (Reynolds, 2016).

A significant quantity of inorganic sediment appears to be present within the lower reaches of Spanish Bank Creek that are north of NW Marine Drive (*Figure 2*). This sediment can negatively affect fish and invertebrates, hinder stream productivity, and impede fish passage (Birtwell, 1999; Suttle, *et al.*, 2004). The watershed of Spanish Bank Creek has experienced significant ecological disturbance due to historic logging and

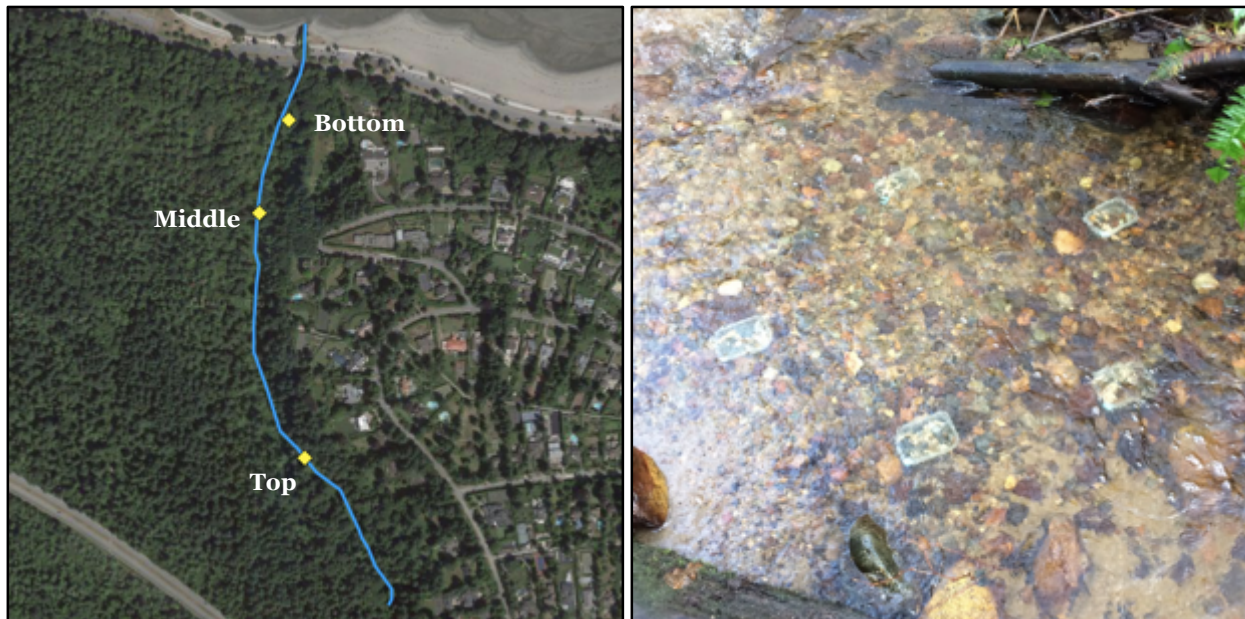
Figure 7: Fifteen sediment accumulators were installed in Spanish Bank Creek. The sediment accumulators were installed in Spanish Bank Creek at locations denoted as top, middle, and bottom (left; QGIS Development Team, 2009). Five accumulators were installed at each of the locations, for a total of 15 accumulators (right; Reynolds, 2016).

As mentioned in 2.4.3 *Topography*, the results of the rebar staking and mapping of runoff inputs into Spanish Bank Creek indicate the downward movement of soils to lower elevations of the watershed. To quantify the rate of sediment loading into Spanish Bank Creek, I installed 15 sediment accumulators in Spanish Bank Creek. Before installation I drilled fifteen 0.16 cm holes into the bottom of each container and then filled them with clean 1.9 cm crushed gravel for drainage and to create void interstitial spaces. On 14 November 2016 the sediment accumulators were installed in Spanish Bank Creek at three locations throughout the length of the stream (*Figure 7*). Five of the accumulators were installed at each of the three locations, totalling 15 sediment accumulators. The tops of the containers were installed to be flush with the natural grade of the stream. At each of the three locations, the five containers were placed in a pentagon formation with approximately 40 cm between each of the containers.

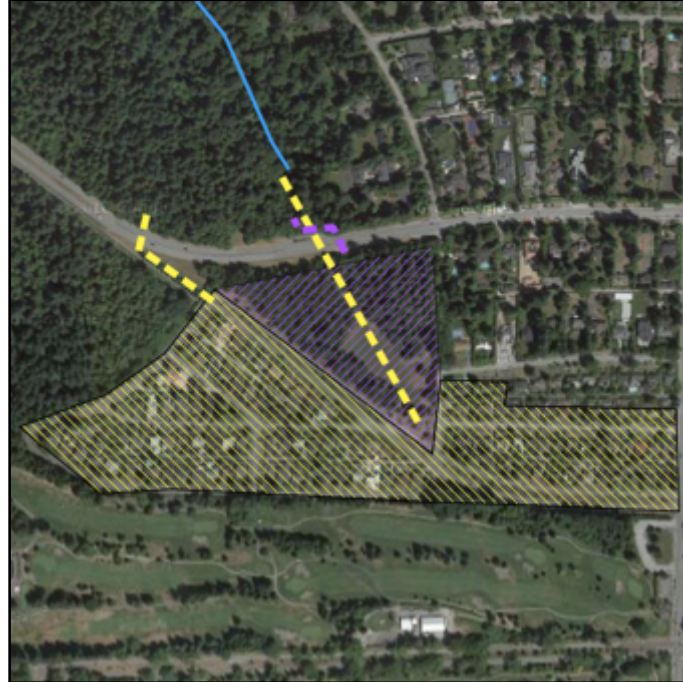
Figure 9: Three culverts drain into the watershed of Spanish Bank Creek. These culverts are indicated by the dashed lines. The polygons indicate the approximate areas that the culverts drain and are paired to the culverts according to colour. The yellow polygon is 12.8 ha, and the purple polygon is 4.7 ha (QGIS Development Team, 2009).

the watershed (*1.6.2 Urban Encroachment*). Currently, there are three culvert outfalls that drain into the watershed of Spanish Bank Creek (*Figure 9*). The primary culvert input of Spanish Bank Creek is a 341.6 m-long culvert that discharges just north of Chancellor Boulevard. This culvert receives inputs from the University Golf Course, and also drains 12.8 ha of Little Australia (A. Galbraith, personal communication, 25 November 2016). In addition, this culvert has penetrated the groundwater table somewhere along its 341.6 m length. This is supported by results from water quality testing (*2.4.5 Water quality*). A secondary culvert drains the north-west corner of Little Australia. This culvert outfall terminates at a ditch just north of Chancellor Boulevard, and the water drains into the forest. The water from this culvert appears to infiltrate into the forest floor except during significant or sustained rainfall events, where a rill has formed in the forest floor. Where this rill meets the steeper slopes of the ravine of Spanish Bank Creek a gully has formed. A third culvert drains a 4.7 ha park that is just north of Little Australia. Just below this culvert's outfall the forest floor is a mosaic of concrete slabs that were probably placed there in an attempt to mitigate erosion (Kahrer, 1991). As a result of these culverts directing storm water in the watershed, discharge in Spanish Bank Creek is tightly coupled to precipitation events. This has led to concerns regarding water quality associated with storm water and golf course drainage (DFO, 1999).

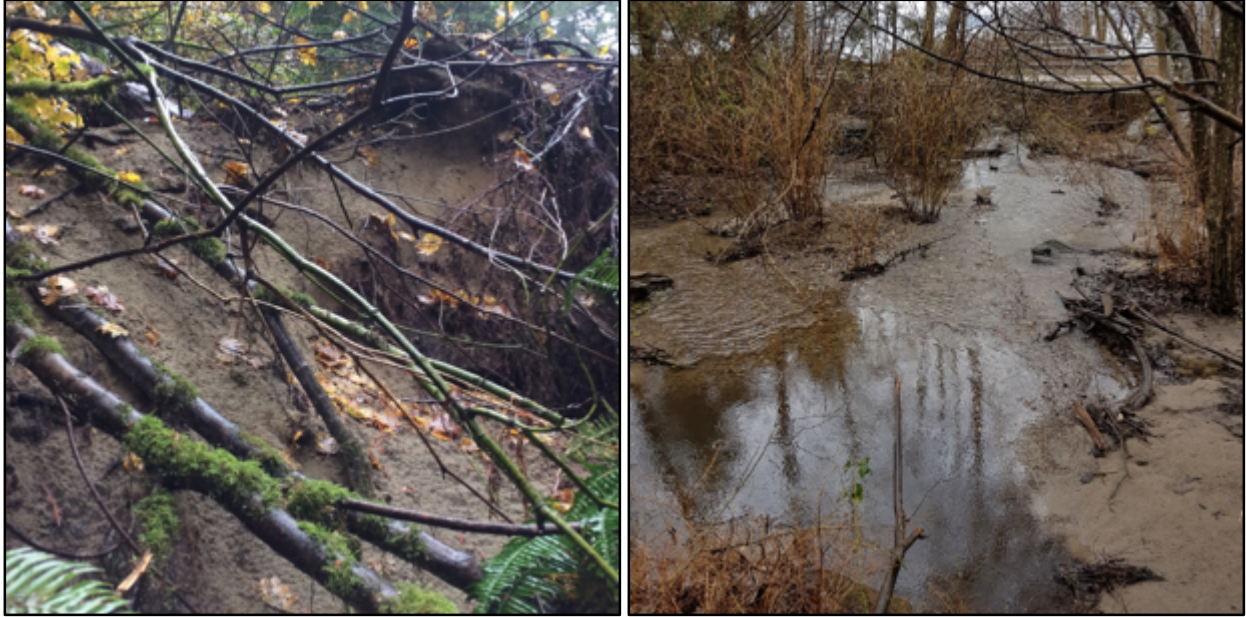
Figure 11: Soils throughout the watershed are eroded and transported to lower elevations. An upturned root wad from a downed tree exemplifies the sandy soils throughout the watershed of Spanish Bank Creek (left). Significant supply of sediment modifies channel morphology (right; Reynolds, 2016).

Soils throughout the watershed of Spanish Bank Creek appear to be largely composed of glaciofluvial sands (Figure 11; GVRD, 2000; Clague *et al.*, 1998; Clague, 1975). As described in the Udden-Wentworth scale of particle sizes, these glaciofluvial particles are likely between 0.5 – 2 mm in diameter (coarse sand to very coarse sand; Figure 13, left). According to the Hjulstrom curves (Figure 13, right), mean flow velocities greater than approximately 0.1 m/s will entrain nearly all particles within this diameter interval.

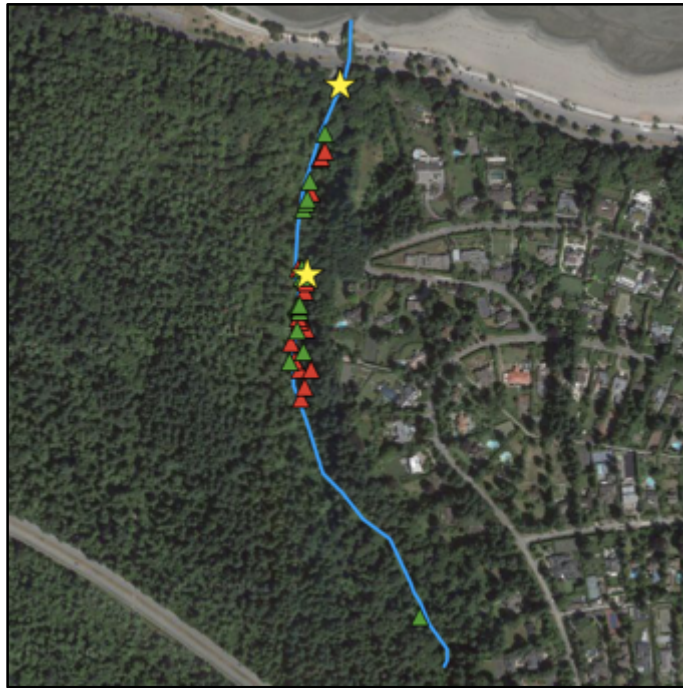
Figure 12: A map of inputs into Spanish Bank Creek. Green triangles represent the 14 runoff inputs from bank left, red triangles represent the 18 runoff inputs from bank right. Yellow stars represent the two drainage pipe inputs into Spanish Bank Creek. Field work was conducted on 4 November 2016 (QGIS Development Team, 2009).

From the streambank mapping, total of 34 inputs were identified (*Figure 12*). Of these 34 inputs, 32 were derived from runoff, and two were derived from drainage pipe outfalls that drain into Spanish Bank Creek. The 32 runoff inputs were likely derived from upslope rills and gullies that are present throughout the watershed. The majority of these rills and gullies are located a significant distance from culvert outfalls. This indicates that the hydrological input that is causing these rills and gullies and associated runoff inputs is derived from precipitation.

This restoration treatment will be conducted in accordance with the objective to mitigate watershed runoff and associated transport of sediment into Spanish Bank Creek. Live staking will be conducted where the 32 runoff inputs enter Spanish Bank Creek (*Figure 12*) as the upslope rills and gullies meet the gentler slopes of the stream's floodplain. The primary species to be used for the live staking will be *Salix spp.* and black cottonwood because of their tolerance for moist conditions (Green and Klinka, 1994; Polster, 2014). Installation of live stakes at each of the 32 runoff inputs into Spanish Bank Creek will require 250 black cottonwood cuttings, and 250 *Salix spp.* cuttings.

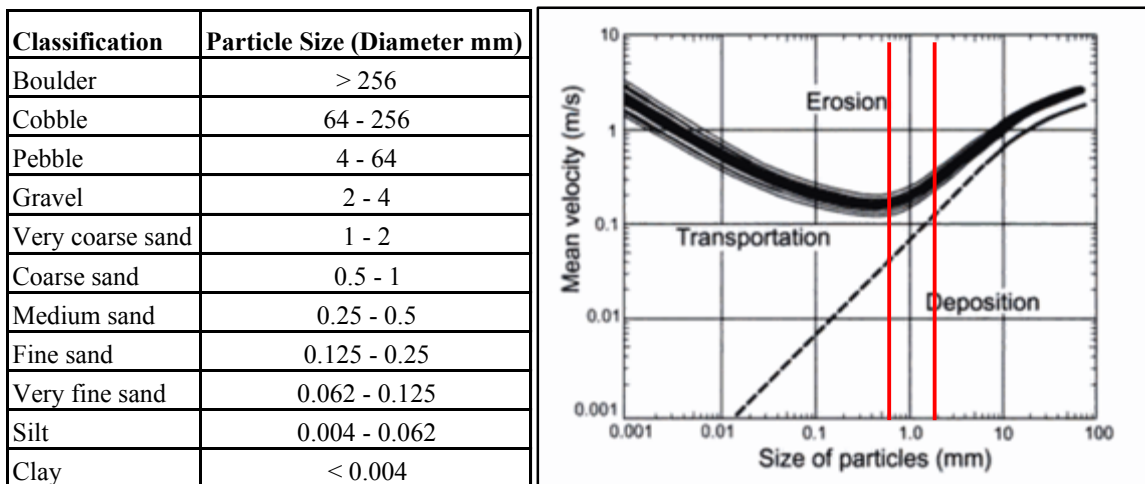
Figure 13: The Udden-Wentworth scale and Hjulstrom curves (Wentworth, 1922; Gordon *et al.*, 2004). The Udden-Wentworth scale of particle size classification (left), indicates that the sandy soils around Spanish Bank Creek are likely 0.5 – 2 mm in diameter. According to the Hjulstrom curves (right), particles of these dimensions, as illustrated between the vertical red lines, will be transported or eroded by flow velocities greater than approximately 0.1 m/s.

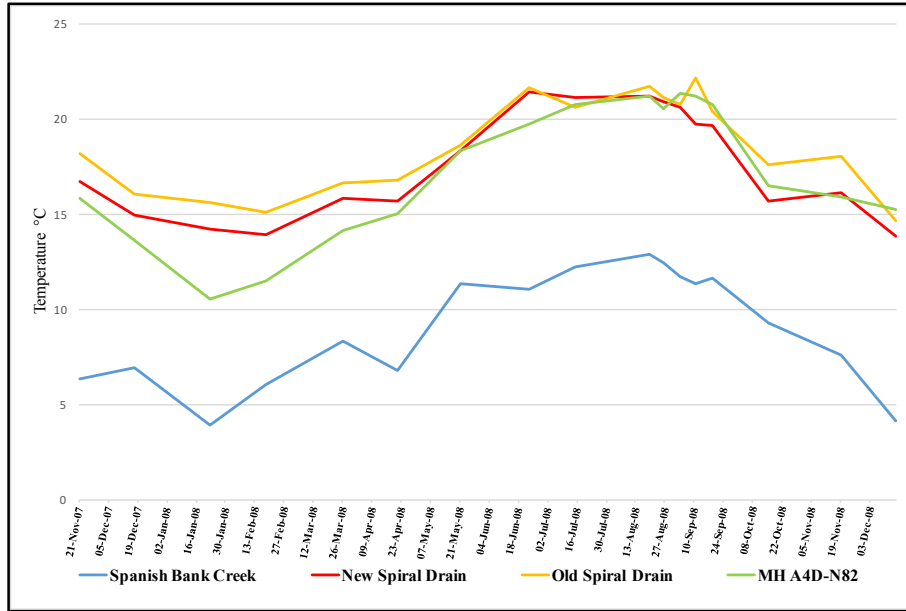
Figure 14: Temperature measured in Spanish Bank Creek and three nearby sites from November 2007 to December 2008.

From the 17 samples, temperature in Spanish Bank Creek was significantly cooler than temperatures recorded at three nearby storm drains over the 14 months (*Figure 14*). Mean temperature in Spanish Bank Creek was 9.0 °C, with a range of 3.9 – 12.9 °C. Mean water temperature measured at three nearby storm drains was 17.6, 18.5, and 17.2 °C, and ranged from 10.5 – 22.1 °C. These results indicate that it is likely that there are groundwater inputs into Spanish Bank Creek that moderate stream temperature year-round. This is supported by the fact that Spanish Bank Creek flows year-round despite a lack of precipitation inputs throughout many summer months.

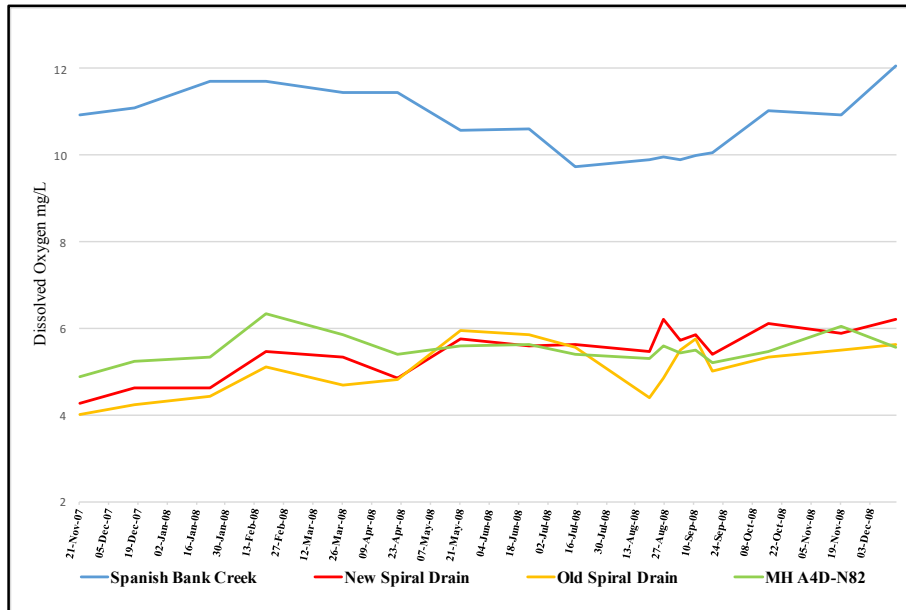
Figure 16: Dissolved oxygen measured in Spanish Bank Creek and three nearby sites from November 2007 to December 2008.

Mean dissolved oxygen measured in Spanish Bank Creek was 10.8 mg/L, with a range of 9.7 – 12.0 mg/L (*Figure 16*). Salmonid embryos display slight production impairment below 9.0 mg/L (Carter, 2005). This means that levels of dissolved oxygen in Spanish Bank Creek from November 2007 to December 2008 were well within the optimal range for salmonids.

From November 2007 to December 2008, dissolved oxygen measured in Spanish Bank Creek was significantly greater than dissolved oxygen measured in the three nearby storm drains. This is likely due to the extensive riffle zones throughout Spanish Bank Creek (2.4.6 *Fish Habitat Assessment Procedure*) that aerate the flowing water.

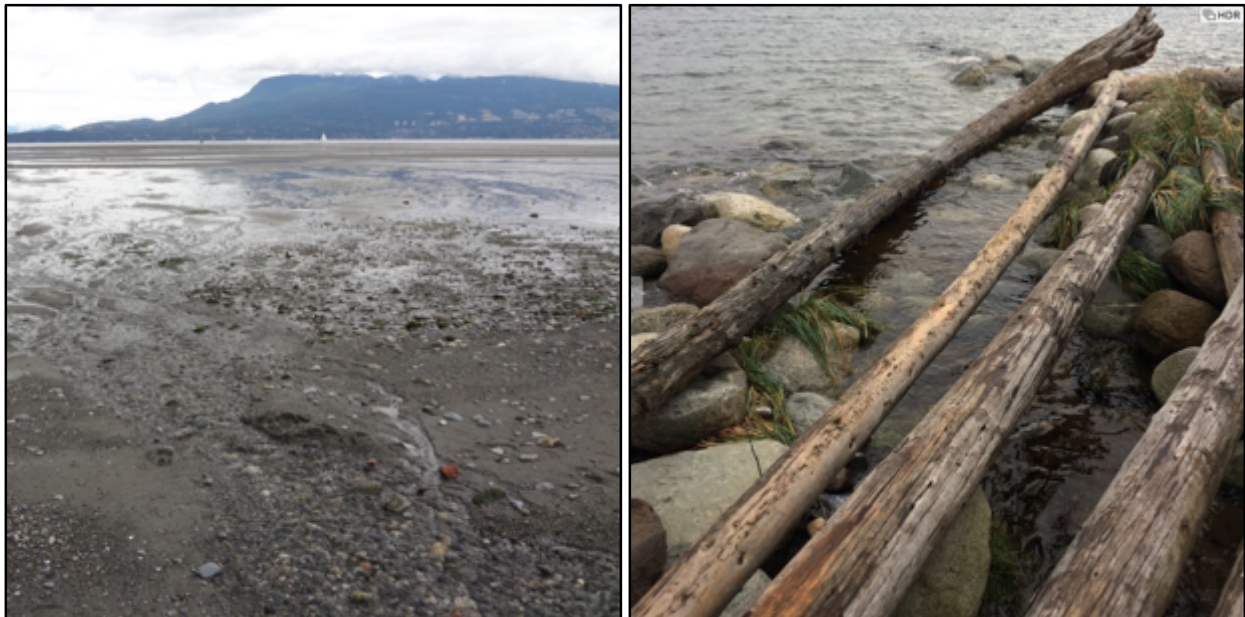
Figure 17: Oceanic tides render Spanish Bank Creek inaccessible except during high tides. At low tide the ocean recedes several kilometers and Spanish Bank Creek is inaccessible (left). Only at high tides is Spanish Bank Creek accessible from Burrard Inlet (right; Reynolds, 2016)

There were three potential barriers to fish passage identified within Spanish Bank Creek. The first potential barrier is at the mouth of Spanish Bank Creek (*Figure 17*). Access to Spanish Bank Creek from Burrard Inlet is only possible during high tides.

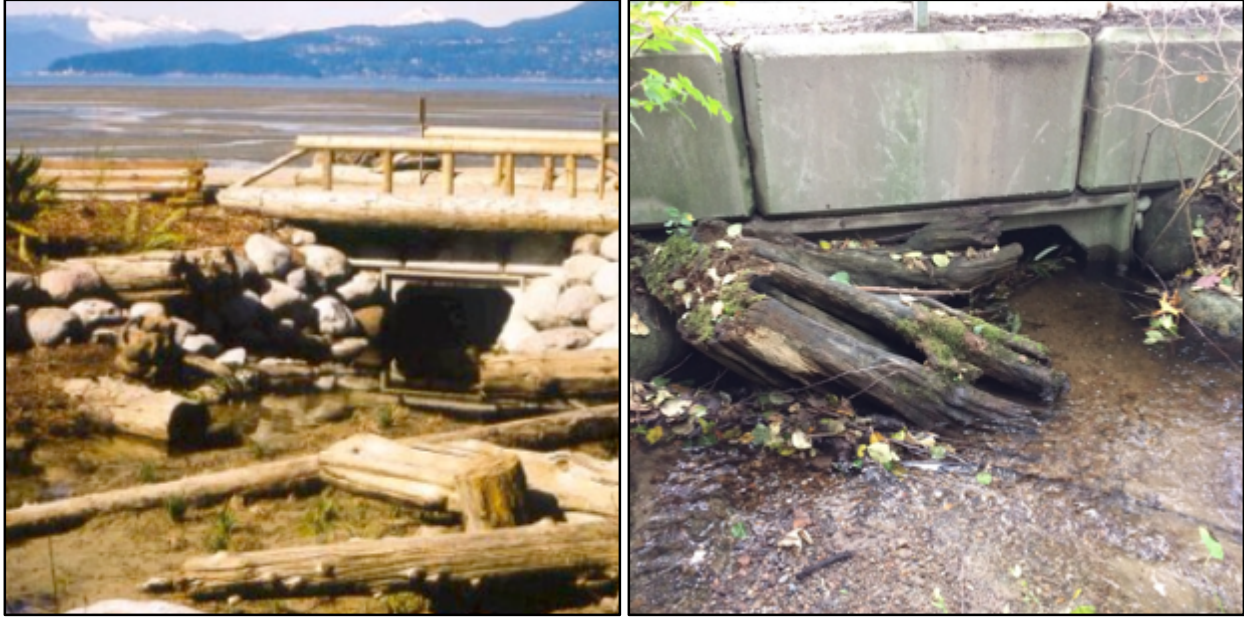
Figure 18: The lower reaches of Spanish Bank Creek have been filled with sediment. Installed in 2000, the concrete box culvert pictured above is 6 m long, 1.2 m tall, and 1.8 m wide (left; Hollick-Kenyon, 2002). After 16 years only a fraction of the culvert is passable due to build-up of sediments (right; Reynolds, 2016).

The second possible impediment to fish passage was identified at the lower reaches of Spanish Bank Creek below NW Marine Drive (*Figure 18*). As Spanish Bank Creek is aggrading at the lower reaches (*2.4.4 Sediment Transport*).

The culvert pictured above is 1.2 m tall and 1.8 m wide. Assuming that the culvert was installed to 1978 British Columbia culvert design guidelines of installation of the culvert 0.31 m below grade (Dane, 1978), 26% of the culvert cross-section would have been buried in the substrate. I recorded measurements of the north and south end of the culvert on 3 March 2017. On the south end of the culvert, approximately 50% of the width of the culvert has been blocked by a cedar stump that is buried in the substrate. In the thalweg to the right of the stump the distance from the substrate to the top of the culvert was 0.6 m. This corresponds to approximately 75% of the culvert cross-section being buried in sediment or blocked by the cedar stump.

The second location of sediment removal at the lower reaches of Spanish Bank Creek is at the culvert under the footbridge (*Figure 18*). Sediment removal will be conducted to increase the depth of water in the culvert to at least 0.23 m under low flow times of the year, as recommended by Dane (1978). For context, water depth at the culvert under the footbridge was 0.04 m on 3 March 2017.

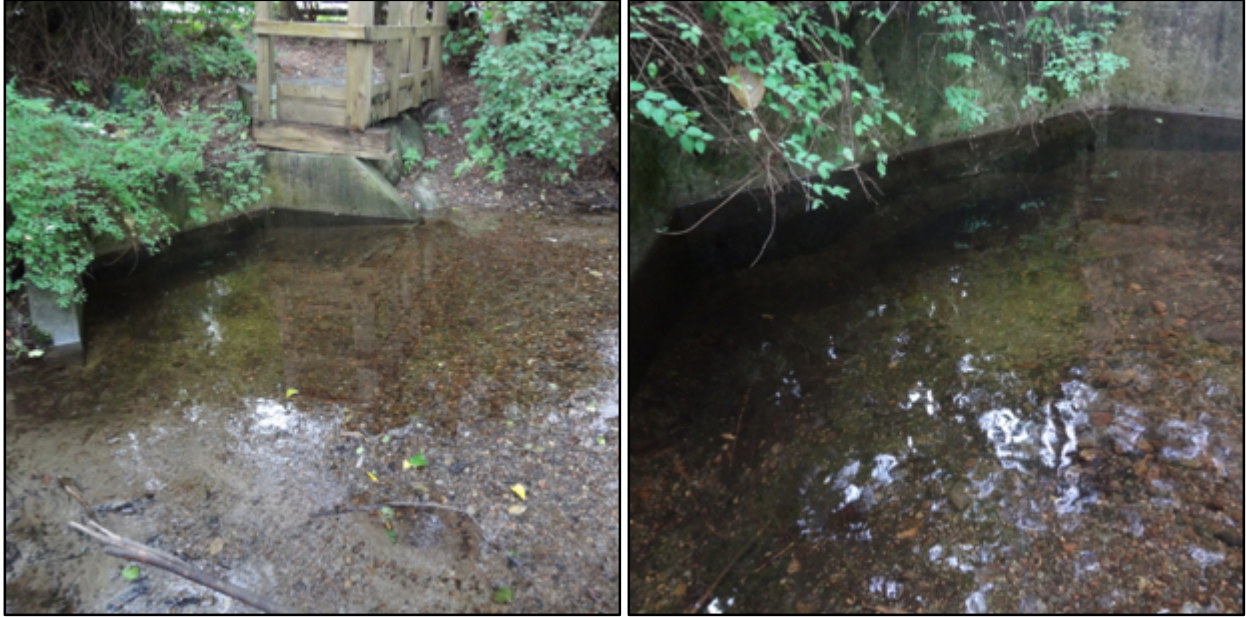
Figure 19: A pre-cast concrete headwall was installed at Spanish Bank Creek. The pre-cast concrete headwall is located at the north end of the wood stave culvert that spans under NW Marine Drive (left). Accretion of sediment has filled in the lower reaches of Spanish Bank Creek, thereby impeding flow through the wood stave culvert (right; Reynolds, 2016).

Approximately 20 m upstream from the concrete box culvert is a wood stave culvert that is 0.90 m in diameter and 20 m in length. This culvert extends under NW Marine Drive. The downstream (north) end of the culvert terminates at a pre-cast concrete headwall (*Figure 19*). Access to the culvert has been impeded by accretion of sediment. Measured on 16 March 2017, the height from the thalweg substrate to the top of the inside edge of the culvert was 0.40 m. This corresponds to 43% of the total cross-sectional area of the culvert that is passable by fish. This measurement assumes that the thalweg is a representative depth for all measurements along the profile of the substrate within the culvert. However, the thalweg typically scours into the substrate, resulting in deeper water depths compared to stream sections not within the thalweg. Therefore, it is probable that there is less than 43% of the total cross-section of the culvert that is passable by fish. If the culvert was installed to 1978 British Columbia culvert design guidelines (Dane, 1978) and the culvert was installed 0.31 m below grade, then 70% of the total cross-sectional area of the culvert was initially passable by fish. Compared to this design parameter, only 61% of the cross-sectional area of the culvert is now passable by fish.

There are three primary locations where sediment will be removed from the lower reaches of Spanish Bank Creek (*Figure 26*). The first location is just north of the pre-cast concrete headwall of the culvert that spans under NW Marine Drive, as seen in *Figure 19*. Removal of sediment will be conducted to increase water flow and fish passage through the culvert. On 16 March 2017, water depth in the thalweg of the north end of the culvert was 0.4 m. The culvert itself is 0.9 m in diameter. This indicates that sediment was blocking more than 50% of the cross-section of the culvert. It is likely that sediment will further block the culvert during summer low flow periods. As recommended by Dane (1978), water depth in culverts should be maintained above 0.23 m for fish passage. If sediment continues to accumulate at the lower reaches of Spanish Bank Creek, fish passage at this culvert could be further impeded. To ensure fish passage through this culvert, water depth along the substrate profile should be maintained at a depth greater than 0.45 m at the pre-cast concrete headwall.

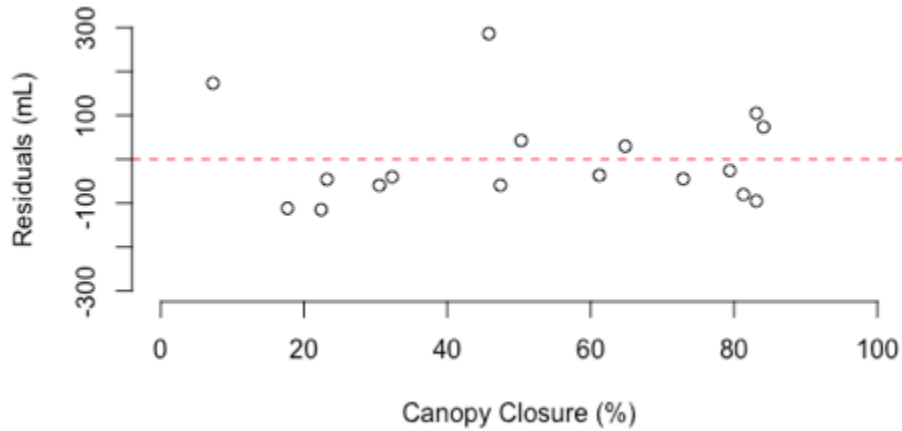
Figure 20: A plot of residuals indicates that data is approximately normally distributed, with no apparent heteroscedasticity.

Mean canopy closure was 50% across all measurement sites with a range of 7 – 84%. Mean precipitation throughfall was 359 mL, with a range of 159 – 684 mL. Histograms indicate that residuals were approximately normally distributed, with no apparent heteroscedasticity (*Figure 20*). The p-value for the F-statistic was less than 0.05 (*Table 5*). Thus, the null hypothesis can be rejected. The calculated R² coefficient value was 0.4. These results indicate that the relationship between canopy closure and precipitation throughfall is significant, and that the linear regression model accounts for

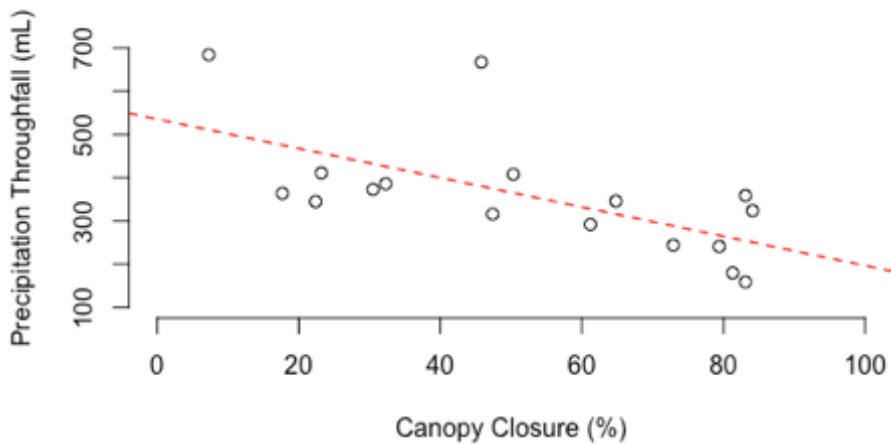
Figure 21: A plot of the relationship between canopy closure and precipitation throughfall, as measured at the three locations, A, B, and C, in the watershed of Spanish Bank Creek.

approximately 40% of the variability in the data. In addition, these results suggest a negative relationship between canopy closure and precipitation throughfall. As canopy closure increases, precipitation decreases (*Figure 21*).

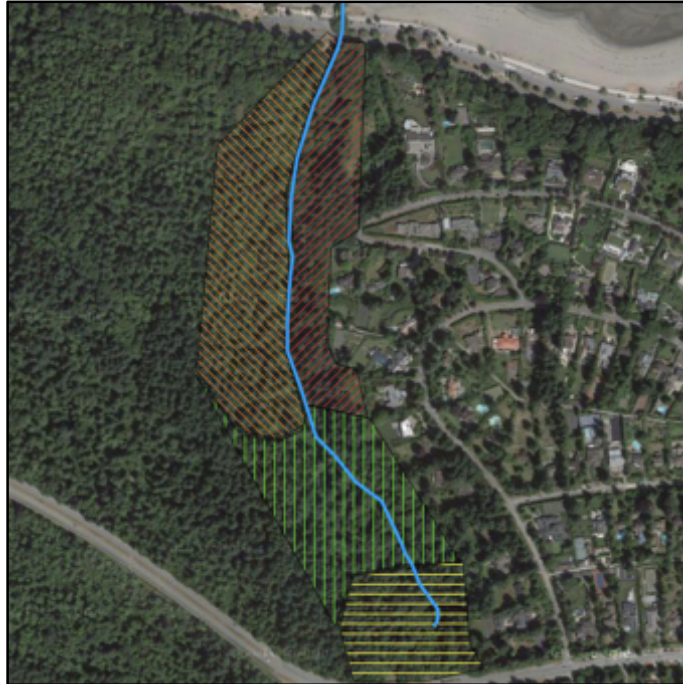
Figure 24: Priority treatment locations for removal of *Hedera* from the canopies of tree throughout the watershed of Spanish Bank Creek. The first priority is the red polygon that is approximately 4 ha. The second priority the orange polygon that is approximately 6.4 ha. The third priority is the yellow polygon that is approximately 3 ha. The last priority is the green polygon that is approximately 5.3 ha (QGIS Development Team, 2009).

Specifically, reduction of *Hedera* from tree canopies will occur every year for five years, will target tree stands within and on the periphery of the ravine of Spanish Bank Creek (*Figure 24*). Ideally, every tree throughout the watershed of Spanish Bank Creek will be treated each year. However, this is unrealistic. Instead, this restoration treatment will occur every year, with the objective to treat every tree throughout the watershed of Spanish Bank Creek at least once by year five.

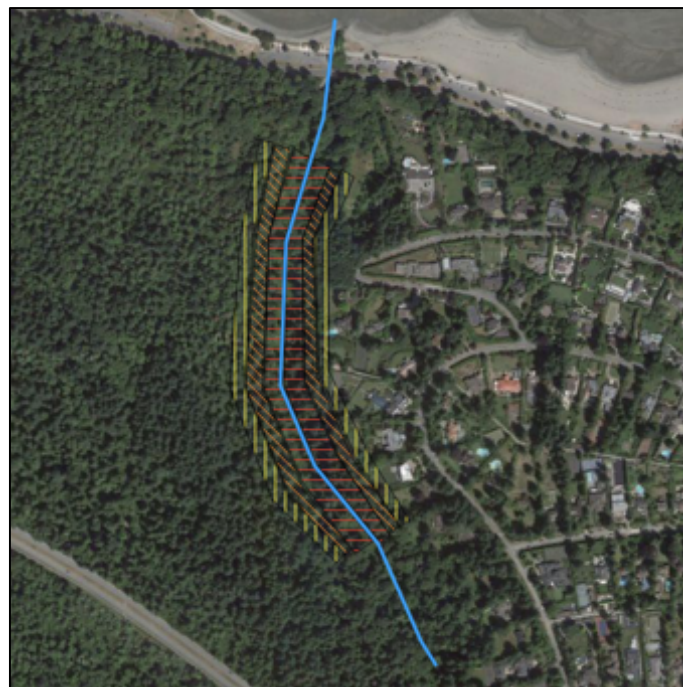
Figure 25: Location within Spanish Bank Creek where the soil bioengineering techniques will be installed. Brush layers will be installed upslope (yellow polygon), live gully breaks will be installed midslope (orange polygon), and live stakes will be installed downslope (red polygon) along the edge of Spanish Bank Creek (QGIS Development Team, 2009).

A total of 2,500 live cuttings will be required to complete all three soil bioengineering techniques at each of the 32 runoff inputs into Spanish Bank Creek and associated rills, gullies, and locations of runoff initiation (*Figure 25*). If *Salix spp.* and red-osier dogwood cannot be sourced, black cottonwood can be used for all the soil bioengineering techniques due to its ability to survive in a range of moisture conditions (Green and Klinka, 1994). The live cuttings should be soaked in water for 48 hours prior to installation, and should be planted immediately after removal from soaking (Hunolt *et*

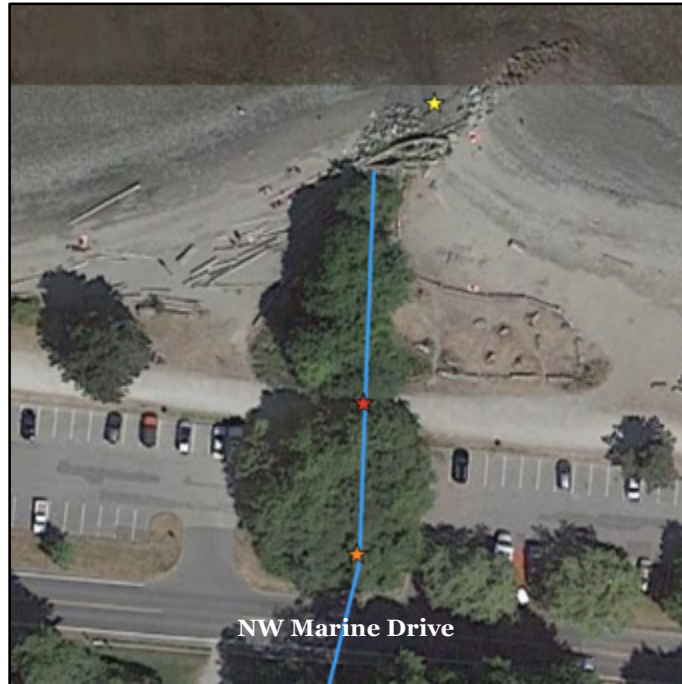
Figure 26: Locations of sediment removal for the lower reaches of Spanish Bank Creek. The first priority is the culvert under the footbridge (red star). The second priority is the pre-cast concrete headwall at the north end of the wood stave culvert (orange star), and the last priority is the mouth of Spanish Bank Creek to re-grade the lower reaches of Spanish Bank Creek (yellow star; QGIS Development Team, 2009).

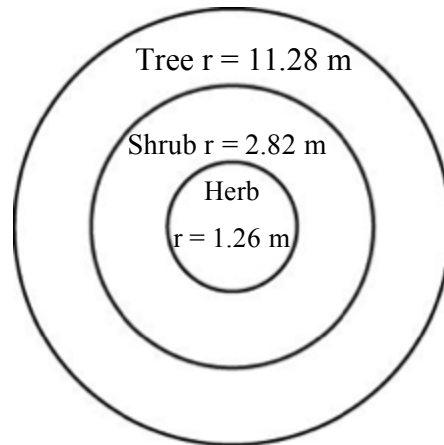
Figure 27: Variable-radius circular plots will be used to quantify vegetation composition at the tree, shrub, and herb layer throughout the watershed of Spanish Bank Creek. These surveys measure percent cover, as well as presence/not detected for vegetation species.

In accordance with reduction of *Hedera* cover from trees throughout the watershed of Spanish Bank Creek, as well as the use of soil bioengineering techniques to mitigate runoff, there will be a change in the vegetation assemblages in the watershed over time. To quantify these changes, variable-radius circular plots will be used. Variable-radius circular plots enable quantification of percent cover of vegetation at herb, shrub, and tree layers. A single survey at a point of interest consists of three concentric, nested circles (*Figure 27*). The largest circle is used to survey vegetation at the tree layer (> 10 m height), and has a radius of 11.28 m, which equals a survey area of 400 m². The medium-sized circle is used to survey vegetation at the shrub layer (< 10 m height, excluding herbaceous species), and has a radius of 2.82 m, which equals a survey area of 25 m². The smallest circle is used to survey vegetation at the herb layer (all herbaceous species, regardless of height), and has a radius of 1.26 m, which equals a survey area of 5 m². Cover mid-points will be used to mitigate bias in assessing percent cover of each species. Results of the vegetation plots will yield percent cover of each species as a function of area. Assuming that the transects and the locations of the vegetation plots along each of the transects are a representative sampling design, inferences about the composition of vegetation for the entire watershed can be made, and changes can be measured over time.
